CEDRUS PROPERTY INSPECTIONS

RESIDENTIAL HOME INSPECTION REPORT

[REDACTED]
Carlsbad, CA 92009

12/27/2025

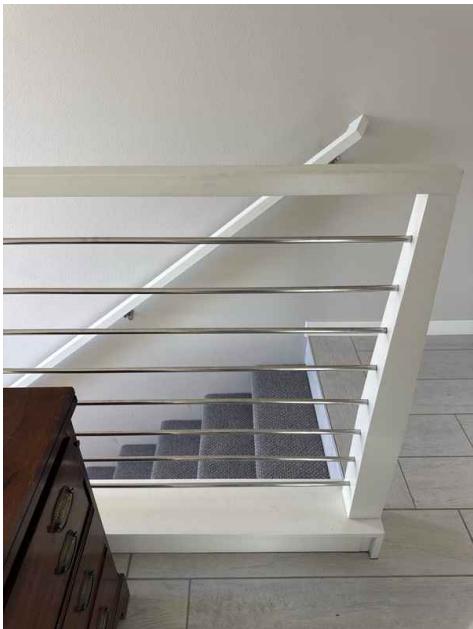
STAIR GUARD CLIMBING HAZARD

Potential climbing hazard for young children.

Moderate Concern

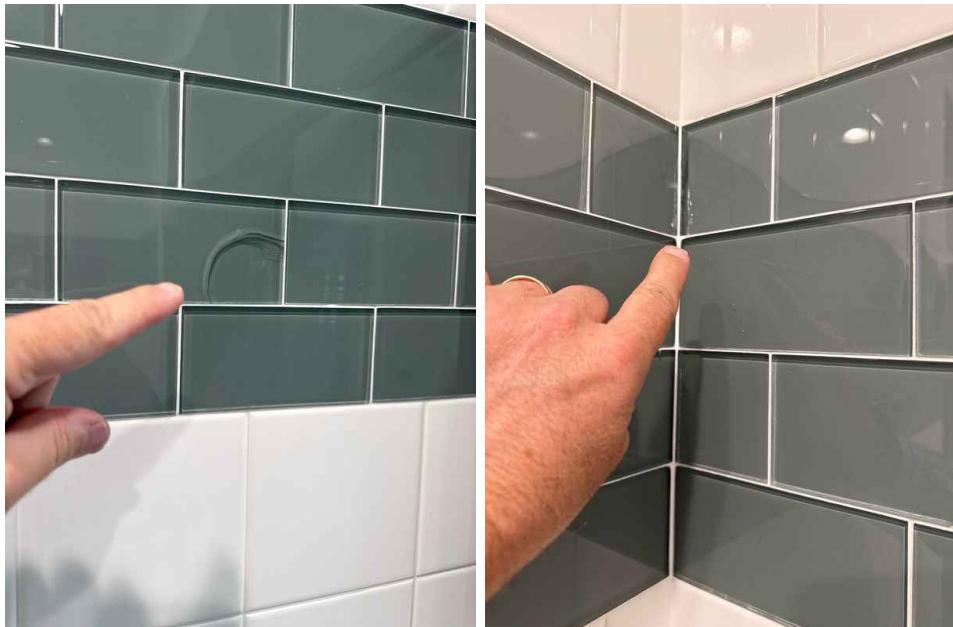
WALL TILES: DAMAGED

Bathroom shower wall tiles were damaged.

Contact a qualified professional.

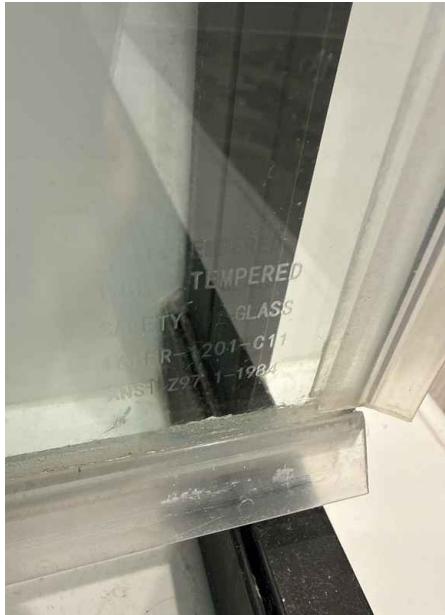
**Shower: Shower Glass Door
Tempered**

Shower glass displayed the proper markings for tempered glass

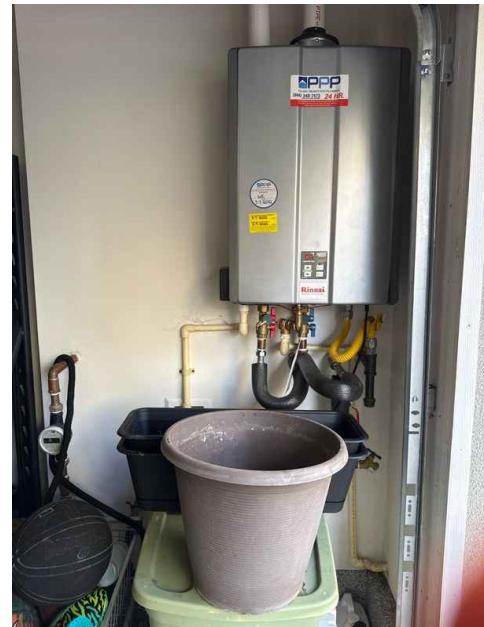
POOR ACCESS, BELONGINGS, NOT INSPECTED

The occupant's belongings blocked access to this water heater at the time of the inspection. Inspection of the water heater was limited to confirmation of proper response. After water heater access has been provided, you should have it inspected by a qualified a qualified HVAC technician or plumbing contractor to determine its condition.
