CEDRUS PROPERTY INSPECTIONS

RESIDENTIAL HOME INSPECTION REPORT

[REDACTED]
Carlsbad, CA 92009

12/27/2025

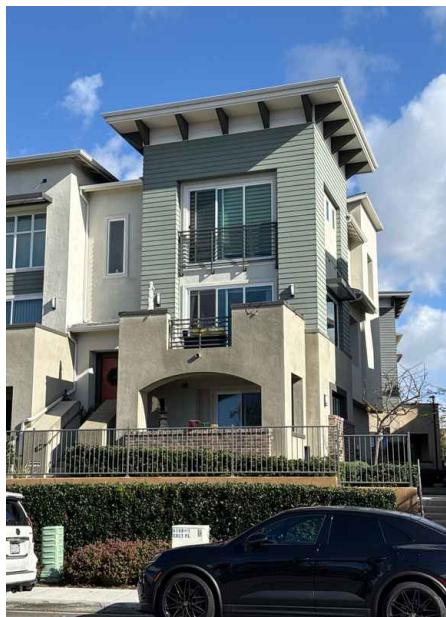
Inspection Conditions: Weather at the inspection

Sunny, Partly cloudy, Light wind

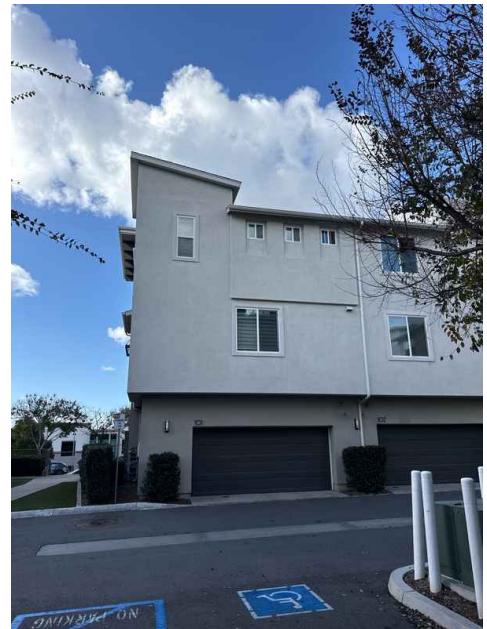
EXCESSIVE HEIGHT: NOT OBSERVABLE

The height of the roof from the ground made it difficult to inspect. This is a limitation.

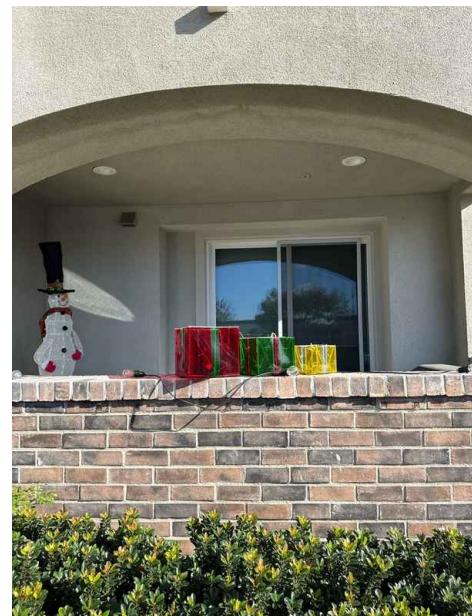
Patio: Patio cover

Wood-framed cover/enclosure

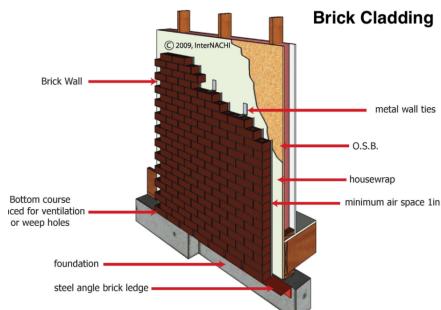
Brick Cladding: Brick cladding

Exterior walls appeared to be conventional wood framing covered on the exterior by brick. Proper modern construction methods include an air gap left between wood framing and the brick, a moisture-resistant barrier (housewrap), and a method for draining to the exterior any moisture that may enter the air gap. Brick is typically fastened to the framing using metal fasteners. Materials behind the brick are no longer readily visible once construction is complete.

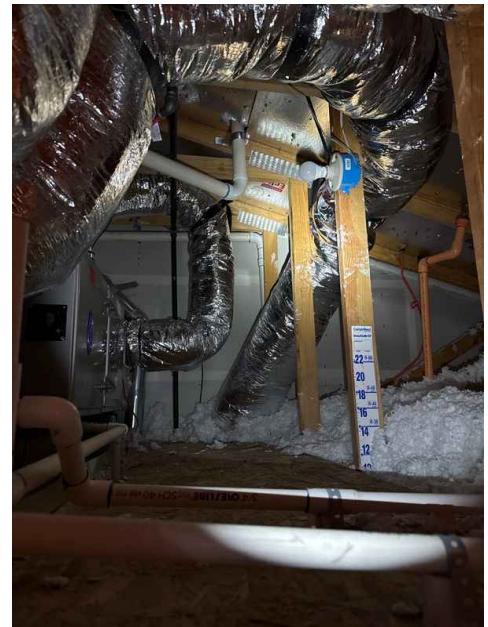
Attic Access**ATTIC ACCESS: INADEQUATE HEADROOM**

The attic space lacked adequate headroom for safe entry. As a result, entering the attic space lies beyond the scope of the General Home Inspection and it was inspected from the hatch only. The Inspection company disclaims responsibility for identifying any deficiencies that were not readily visible during inspection.

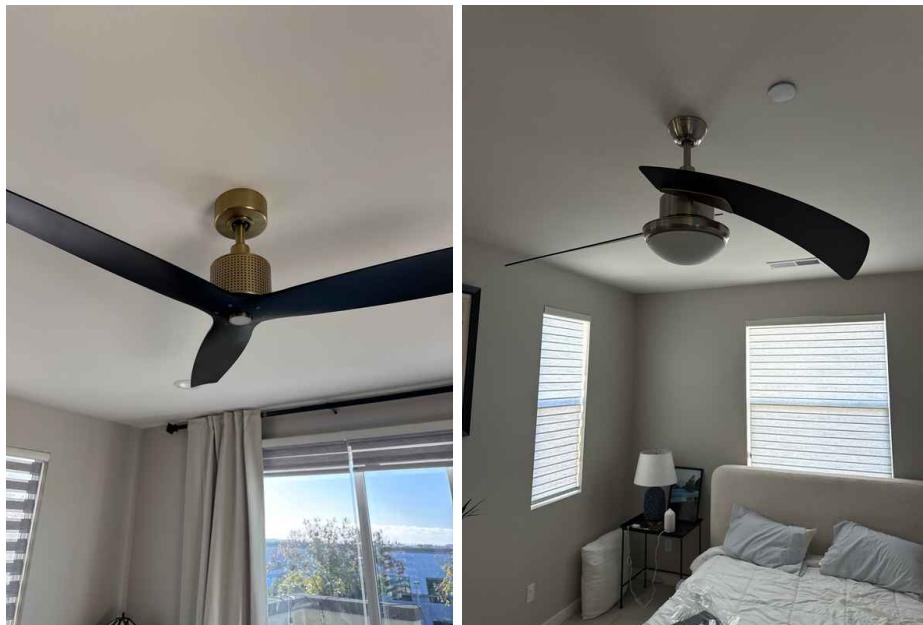
Ceiling Fan: Ceiling fans

Located in the main family room and upstairs bedroom. Operated with remotes at the time of the inspection.

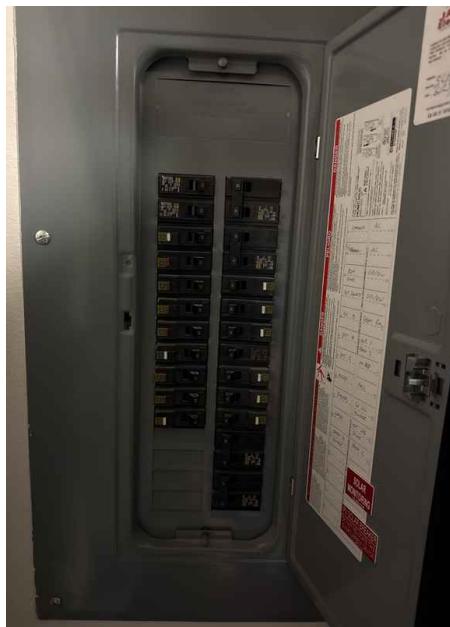
Sub-Panel: Disconnect: no single disconnect- OK

This sub-panel had no single disconnect controlling circuits. Shutting off power to the circuits controlled by this sub-panel required turning off individual circuit breakers, or shutting off power to the entire sub-panel using a disconnect located at the service panel.

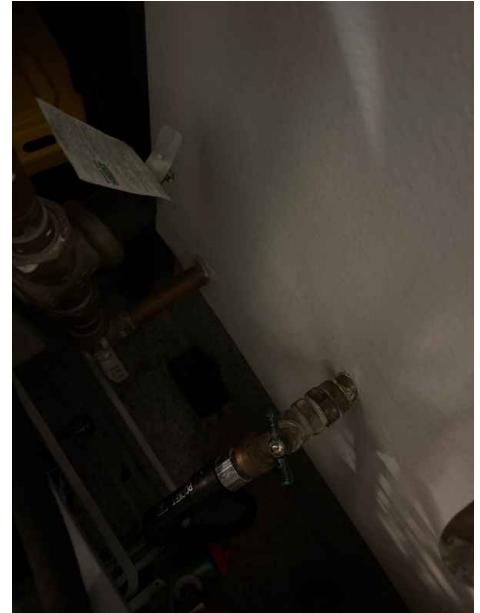
Water Supply and Distribution:**Main water shut-off: location**

The main water supply shut-off was located in the garage.

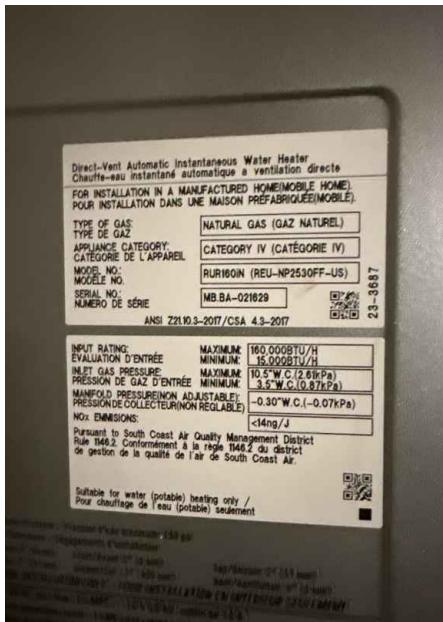
Water Heater: Data plate: photo

The photo shows the data plate of this water heater.

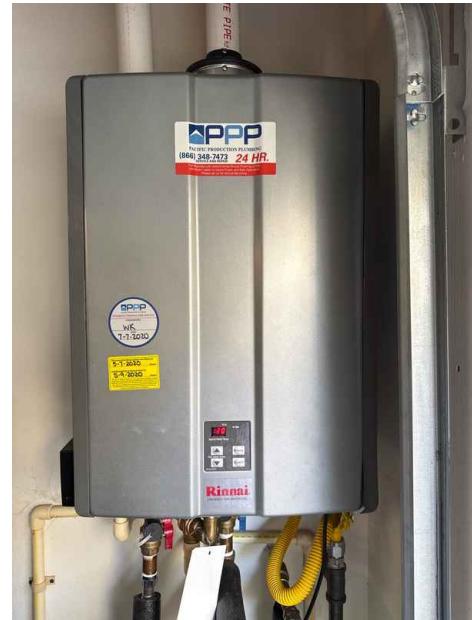
Water Heater: Photo of water heater

The photo shows the data plate of the water heater.

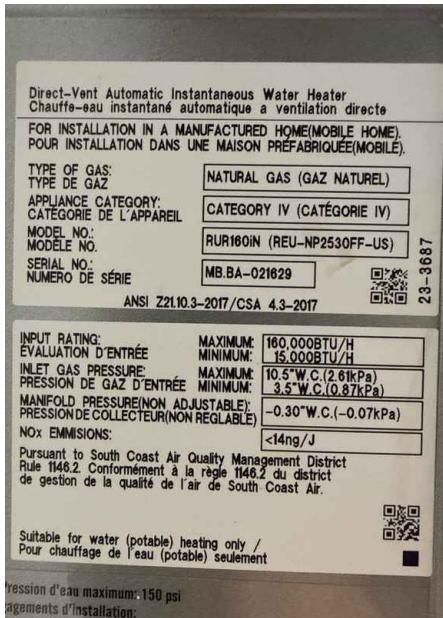
Water Heater: Serial number

This water heater serial number can be viewed from the photo.

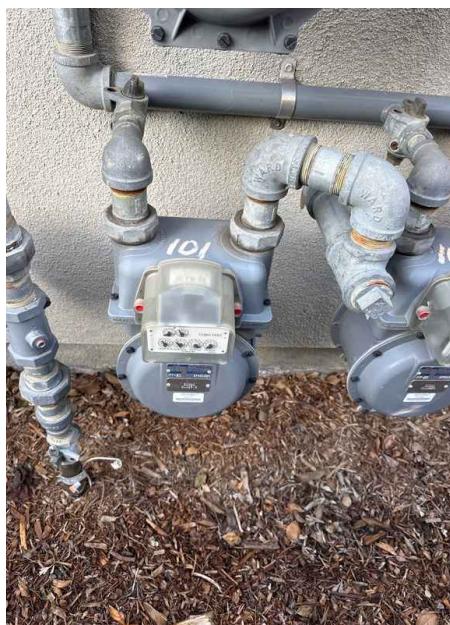
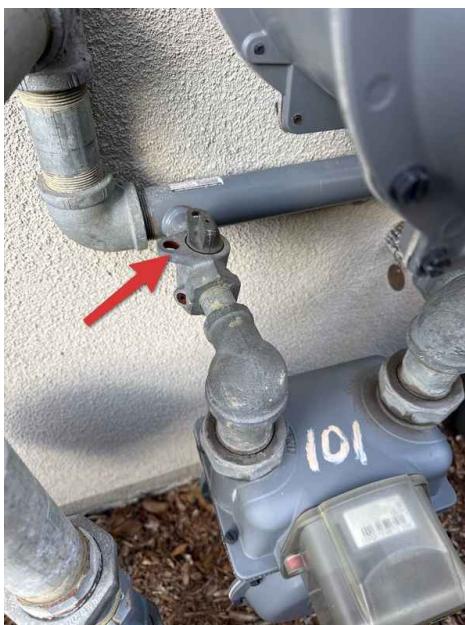
Water Heater: Gas: photo, shut-off valve: gas

The photo shows the location of the shut-off valve for gas at the water heater. It is located on the side of the dwelling unit.

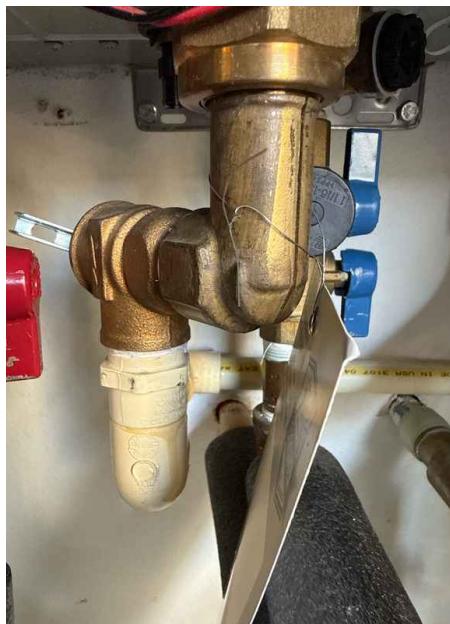
Water Heater: TPR valve: present

The water heater was equipped with a temperature/pressure relief (TPR) valve that was not operated by the Inspector. Operating the TPR valve lies beyond the scope of the General Home Inspection. The Inspector recommends that the TPR be operated by the homeowner monthly as a maintenance measure.

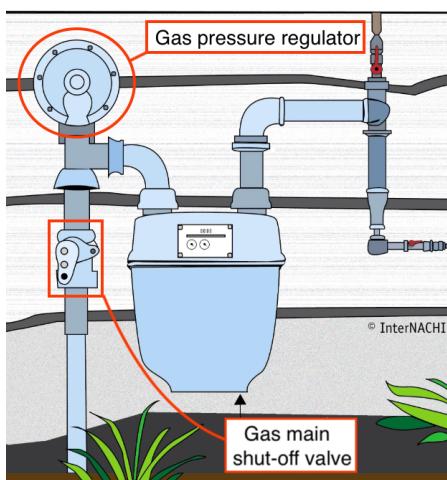
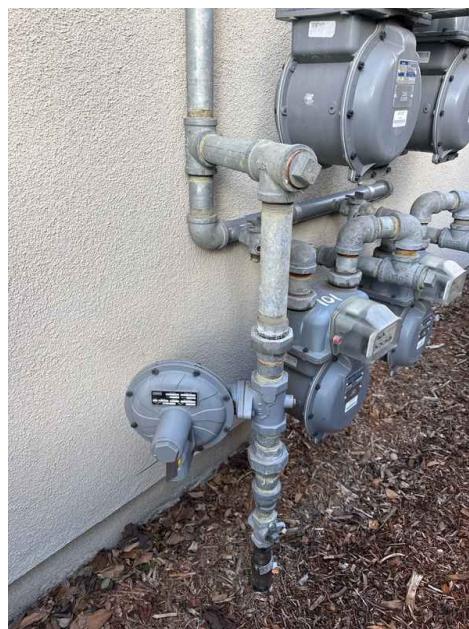
Gas System: Gas meter: photo of regulator

The gas pressure regulator that controls the pressure under which gas is supplied to the home. Gas regulators leak small amounts of gas occasionally. If gas smell is strong and persists, contact your local gas utility provider.

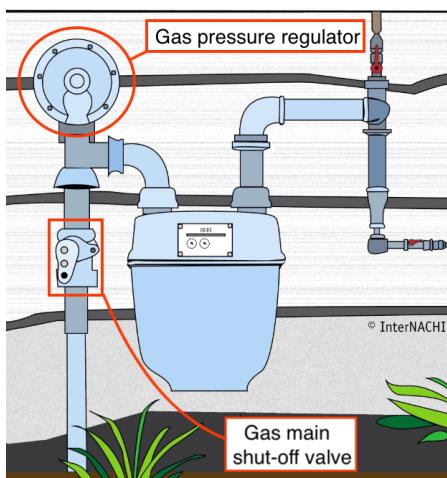
Gas System: Main gas shut-off at gas meter

The main gas shut-off to the home was located at the gas meter.

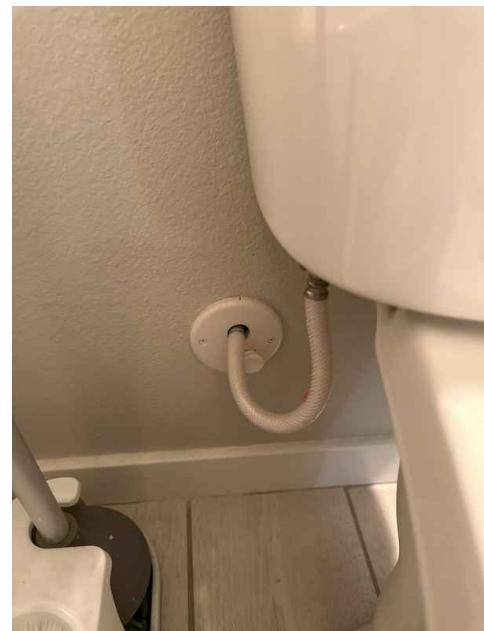
TOILET/SINK WATER SUPPLY SHUT OFF, NOT OPERATED

Water supply shut-off valves for the toilets and sinks were not operated but were evaluated visually only.

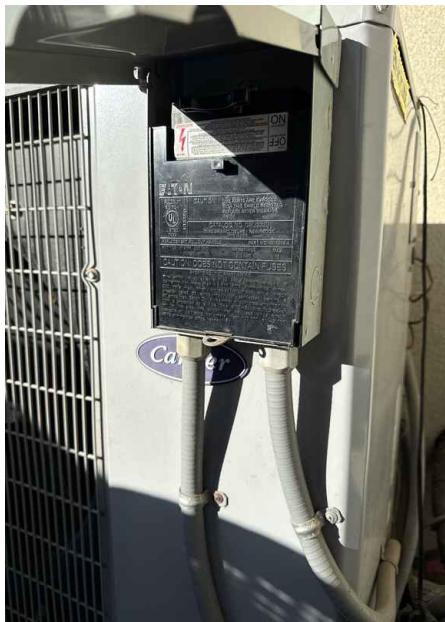
Cooling: Condenser: disconnect at sub-panel

The air-conditioner disconnect was located at a sub-panel.

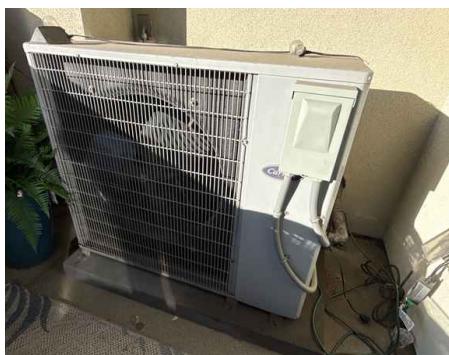
Cooling: AC: split system description

The air conditioning system was a split system in which the cabinet housing the compressor, cooling fan and condensing coils was located physically apart from the evaporator coils. As is typical with split systems, the compressor/condenser cabinet was located at the home's exterior so that the heat collected inside the home could be released to the outside air. Evaporator coils designed to collect heat from the home interior were located inside a duct at the furnace and were not directly visible.

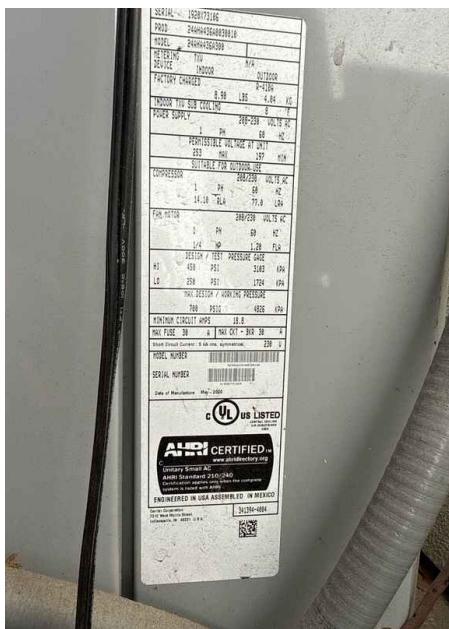
Cooling: Condenser: data plate, photo

Information from the air-conditioner compressor unit data plate is shown in the photo.
